MASSIMILIANO PANESSA Yacht & Small Craft Surveyor

Report nr. 22072PP
Date of inspections: 21/06/2022
Where inspected:: Marina San Giorgio boatyard
S. Giorgio di Nogaro, Italy
Customer: Mr. Christoph Schmid
Grossplatestrasse 20, Pfaffhausen - Switzerland
Kind of survey: Pre purchase

Inspection report
Auxiliary Engine Sailing Yacht named:

BRITTA

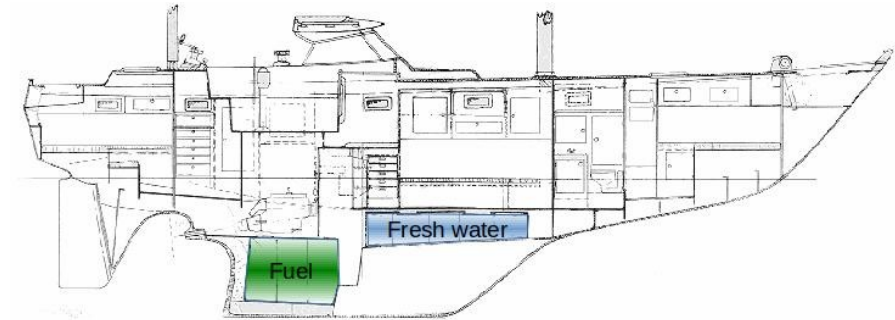
The external cast iron ballast moulding was in serviceable condition, showing slight visible indication of damage caused by grounding with **no visible cracks but for a small one on fore port side with water leaking. The area must be restored to avoid further water infiltration.**

The aft part of keel moulding hosts the fuel tanks as showed in the diagram below. The draining plug present in this kind of boat on the lower part of the keel was closed by a fibreglass layer

Fresh water tanks are located above ballast, also showed in the diagram.

RECOMMENDED: Locally fix the crack on forward lower corner of keel moulding.

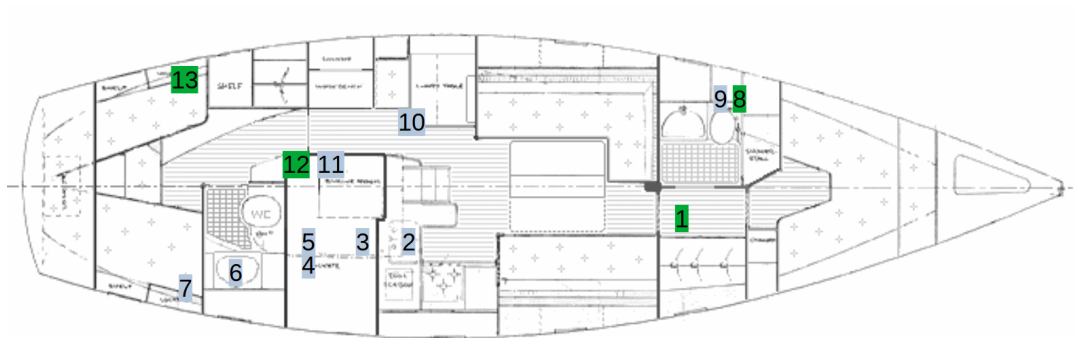
1. *Diagram 3.1.a - Skin fittings identification*

- (1) Forward Heads inlet: A metal thru-hull fitting ball valve showing slight corrosion, to be replaced after the next season, a second stainless hoseclips must be added

- (2) Galley sink outlet: A thru-hull fitting with composite ball valve in good condition.
- (3) Cockpit drain: A metal thru-hull fitting ball valve in good condition.

- (4) Bilge pump outlet: A thru-hull fitting with composite ball valve made by Truedesign in good condition.
- (5) Black Water outlet: A thru-hull fitting with composite ball valve made by Truedesign in good condition.

- (6) Aft Heads Basin outlet: A metal thru-hull fitting ball valve in fair condition with slight oxidation.
- (7) Deck Drain: A thru-hull fitting with composite ball valve made by Truedesign in good condition.

- (8) Forward Heads Basin outlet: A metal thru-hull fitting ball valve in poor condition showing oxidation and dezincification, to be replaced after next season.

- (9) Black Water outlet: A thru-hull fitting with composite ball valve made by Truedesign in good condition.
- (10) Cockpit drain: A metal thru-hull fitting with gate valve in good condition

- (11) Engine cooling intake: A thru-hull fitting with composite ball valve made by Truedesign in good condition.
- (12) Aft Heads inlet: A metal thru-hull fitting ball valve in good condition, a second stainless hose clips must be added.

- (13) Deck drain: A metal thru-hull fitting with gate valve in fair condition, blocked, to be serviced.

RECOMMENDED: Replace the forward heads inlet and washbasin drain seacocks at the end of next season.

Replace metal thru-hull fittings at a five year interval.

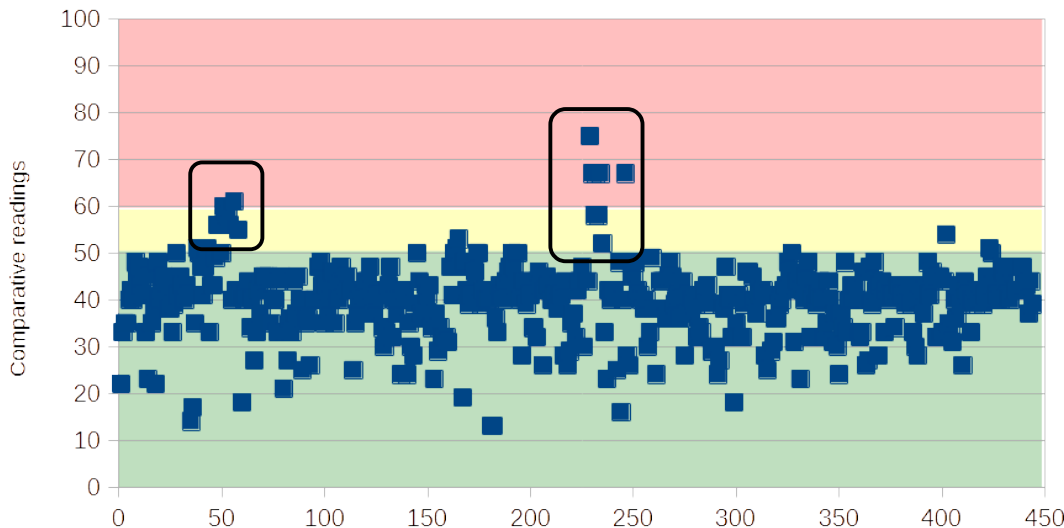
- d) Moisture test Performed all over the hull, reported readings almost everywhere below instrument warning. Highest readings were found on the skeg and on the rudder.

- From such readings the hull can be considered dry.
- At the dedicated paragraph at the end of the report are visible the gathered data.
- e) Keel-hull join The cast iron ballast was encapsulated within the hull moulding and no join is visible either from outside and inside the hull; no indication of ballast defects noted at a visual inspection.

Graphic 1: Highlighted reading were taken in way of rudder and skeg
